Manhole Inspection Summary

Manhole # S17EE1017MH

Location Address: **2400 KEYWORTH AVE**

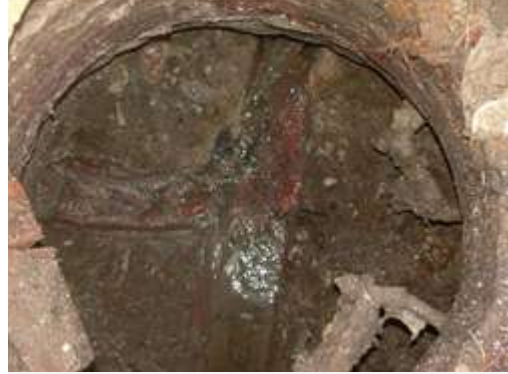
Top View

Corroded steps. Evidence of surcharge - Bench debris.

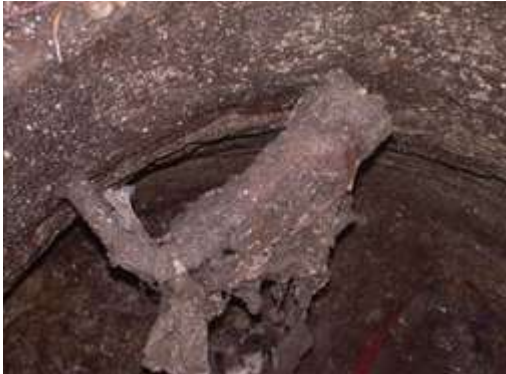
Evidence of surcharge

Surcharge ☒ **Evidence Of Surcharge** Depth: **6** (ft.) ☐ Active Surcharge Present

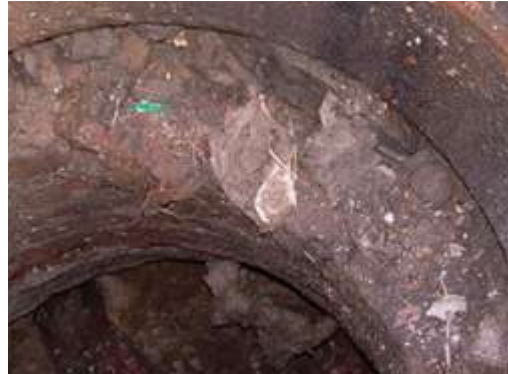
Defect

Frame leaks. Frame offset. Adjustment deterioration and infiltration. Corbel and Barrel infiltration.

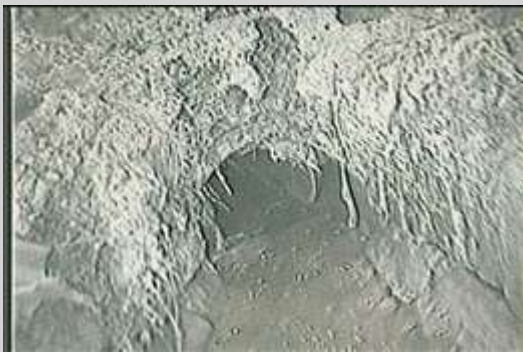
8 in. Circular Gravity Sewer Pipe Out @ 12 O'Clock

Infiltration: **Evidence** Pipe Seal Cond: **Roots**

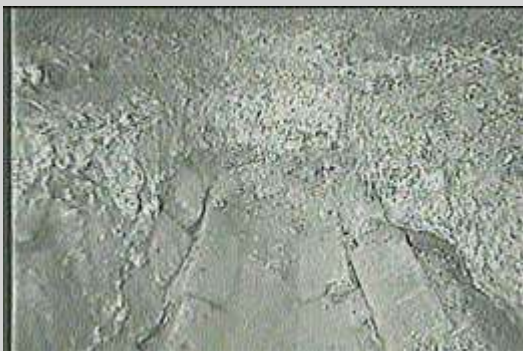
Pipe In @ 6 O'Clock

Channel deterioration.
